**INDIVIDUAL PROPERTY/DISTRICT
MARYLAND HISTORICAL TRUST
INTERNAL NR-ELIGIBILITY REVIEW FORM**

Property/District Name: Edward T. Clark Farm Survey Number: HO-647

Survey No. HO-647
Edward Talbott Clark Farm
Buildings Complex
Howard County, MD

**Maryland Historical Trust
State Historic Sites Inventory Form**

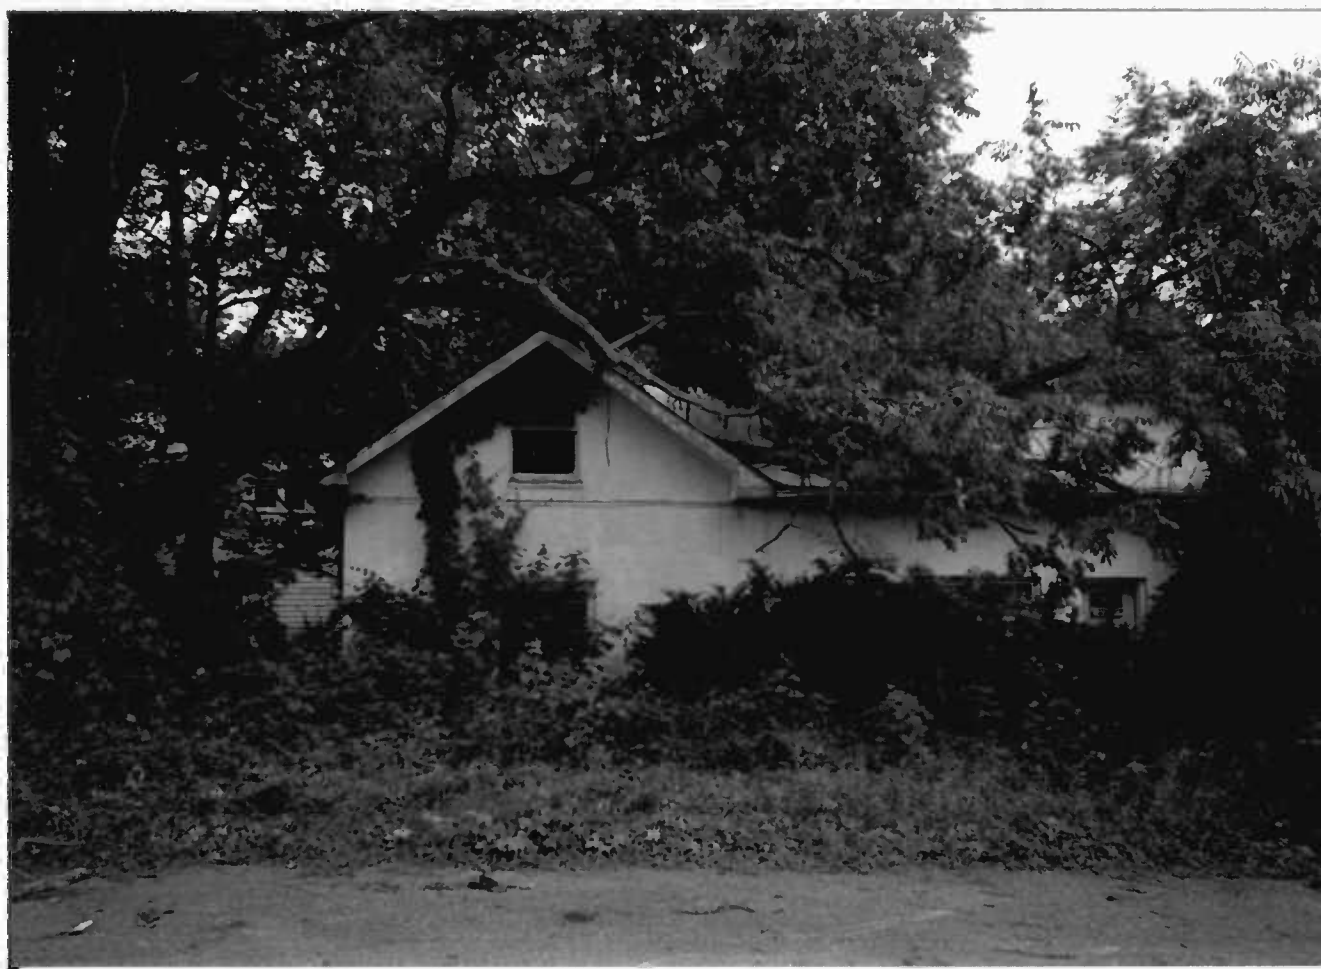
1 OF 13

This dwelling is rectangular in shape, 31 feet wide by 43 feet long. The long axis of the building is oriented along a 64 degree magnetic azimuth. This building is constructed of cement block and its exterior finish is stucco. There is a crawl space under the house. The windows are double hung, six over six. The exterior walls of the structure are in good condition. The interior of the building is deteriorated due to lack maintenance. The roof is of the gable type and is "T" shaped. Two brick chimneys extend through the roof, which is covered with asphalt shingles. The roof is severely deteriorated and partially collapsed.

STRUCTURE #1, MINIMAL TRADITIONAL STYLE
DWELLING, FRONT ELEVATION, LOOKING SE.

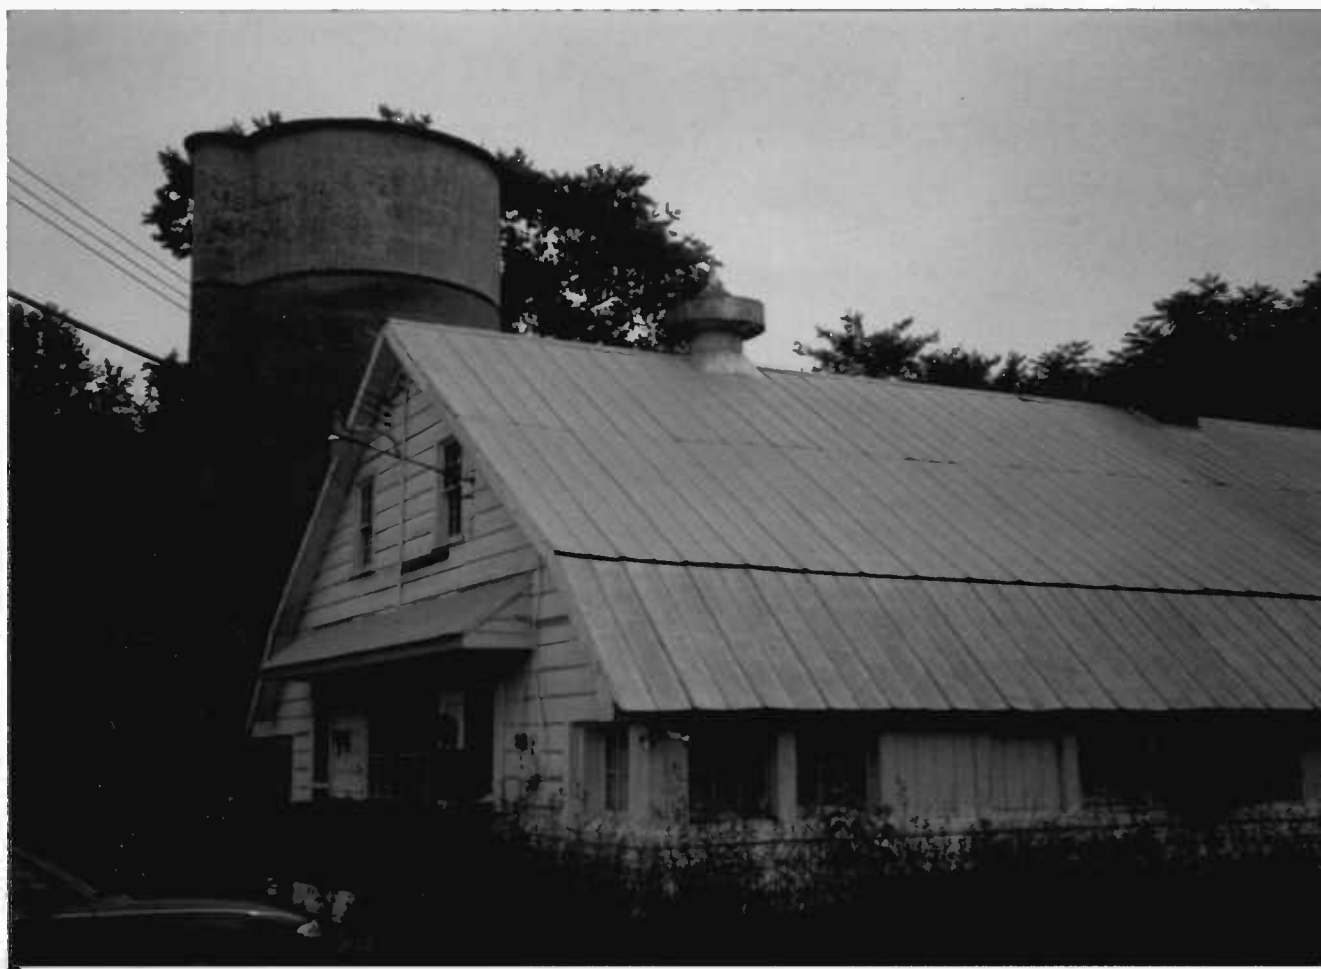
3 OF 13

The side walls of Structure # 2 are constructed of concrete masonry units (CMUs) with a 5-inch concrete cap. Above the masonry along both sides of the barn there is a nearly continuous row of six pane sash windows, each 32 inches wide by 30 inches tall. Some of the window openings have been closed off with plywood.

STRUCTURE #2, DAIRY BARN, SIDE ELEVATION,
LOOKING S.E.

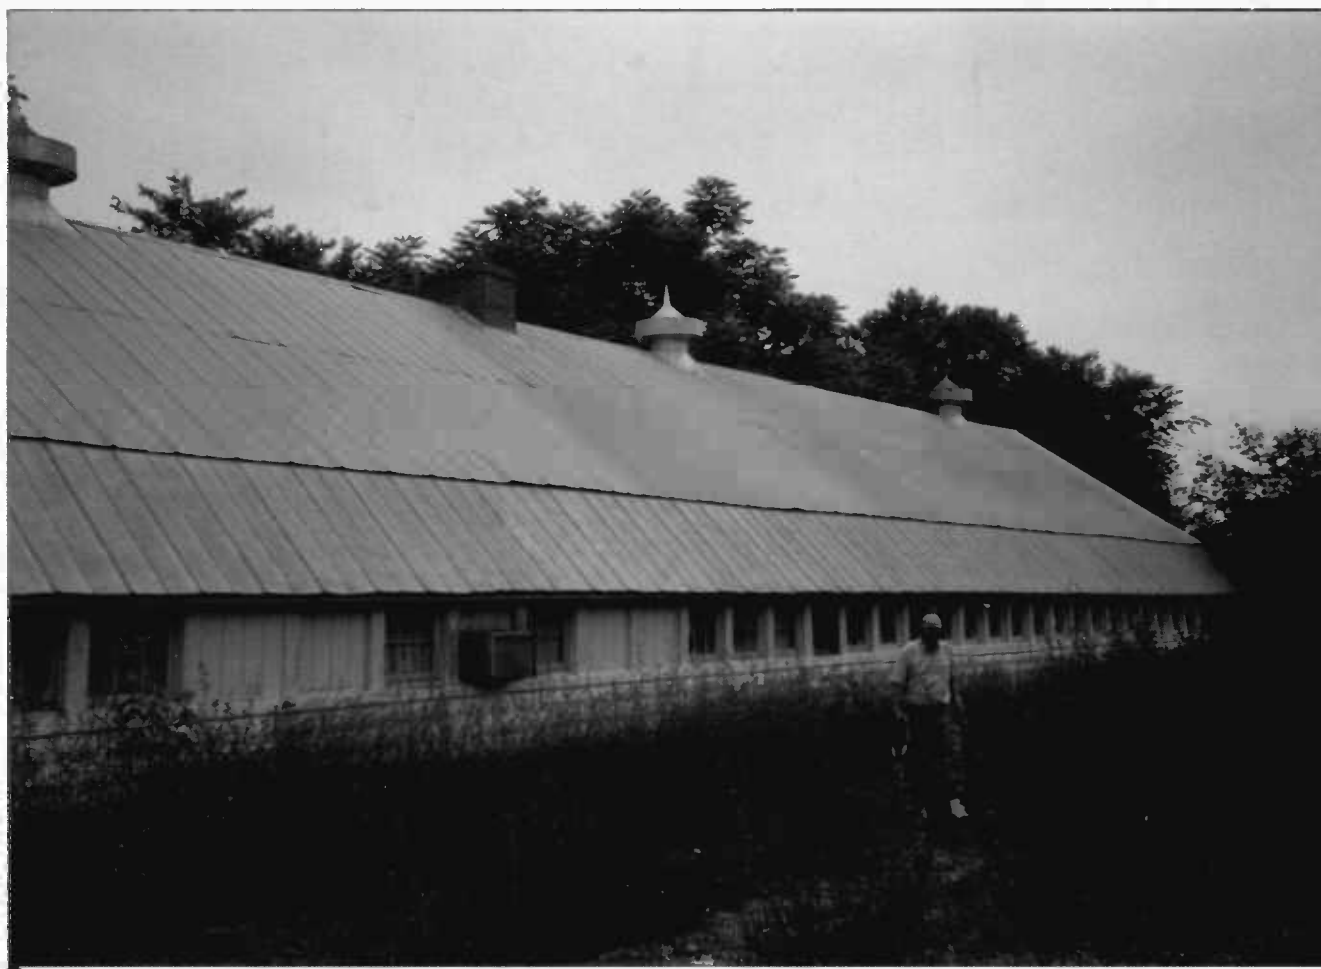
4 OF 13

STRUCTURE #2, DAIRY BARN, SIDE ELEVATION,
LOOKING S.E.

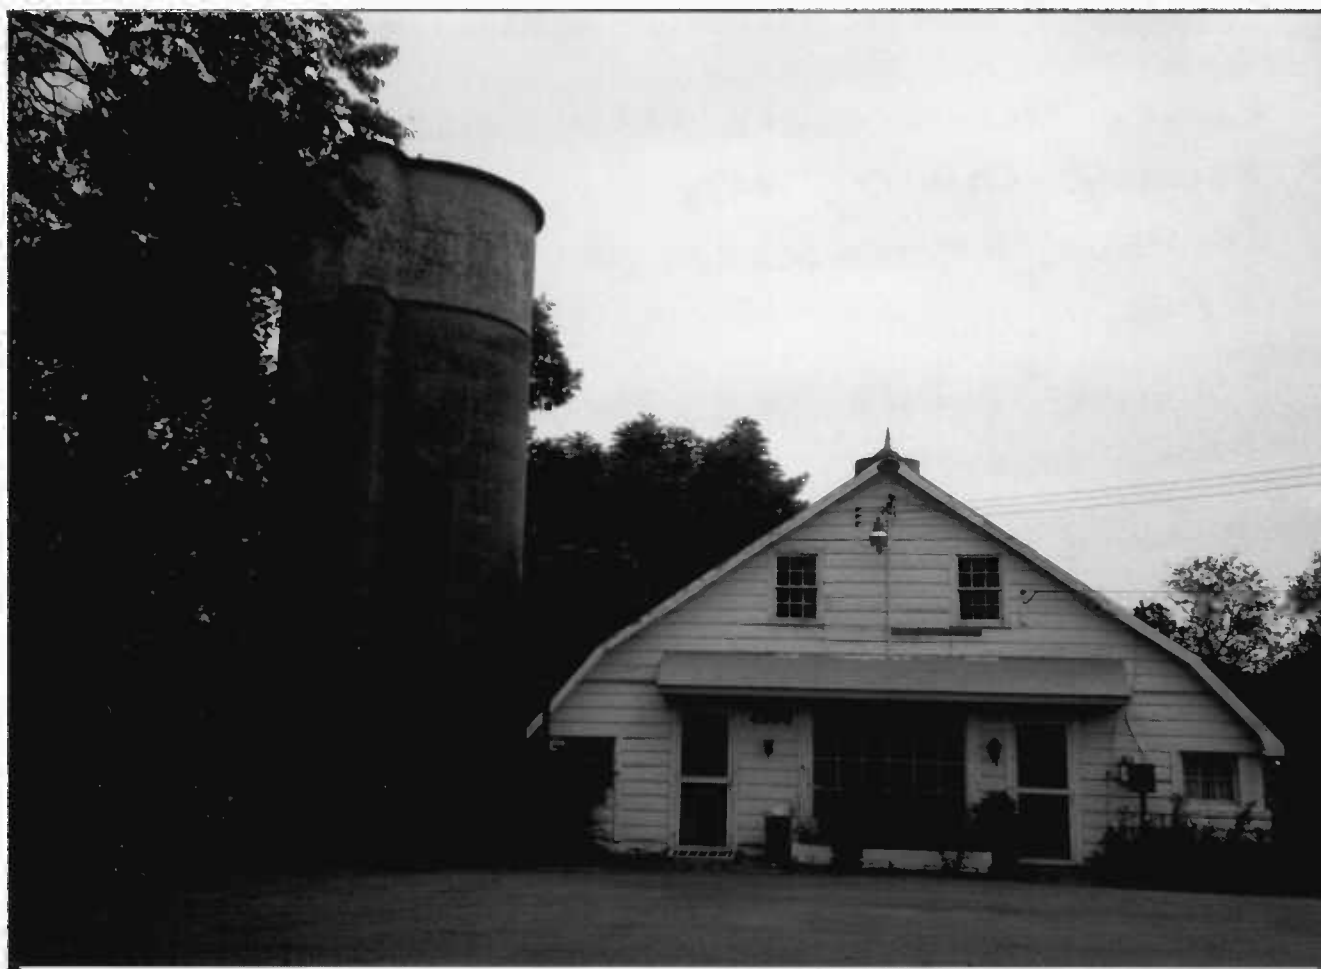
5 OF 13

STRUCTURE #3, SILO, AND STRUCTURE #2, DAIRY BARN
FRONT ELEVATION, LOOKING S.W.

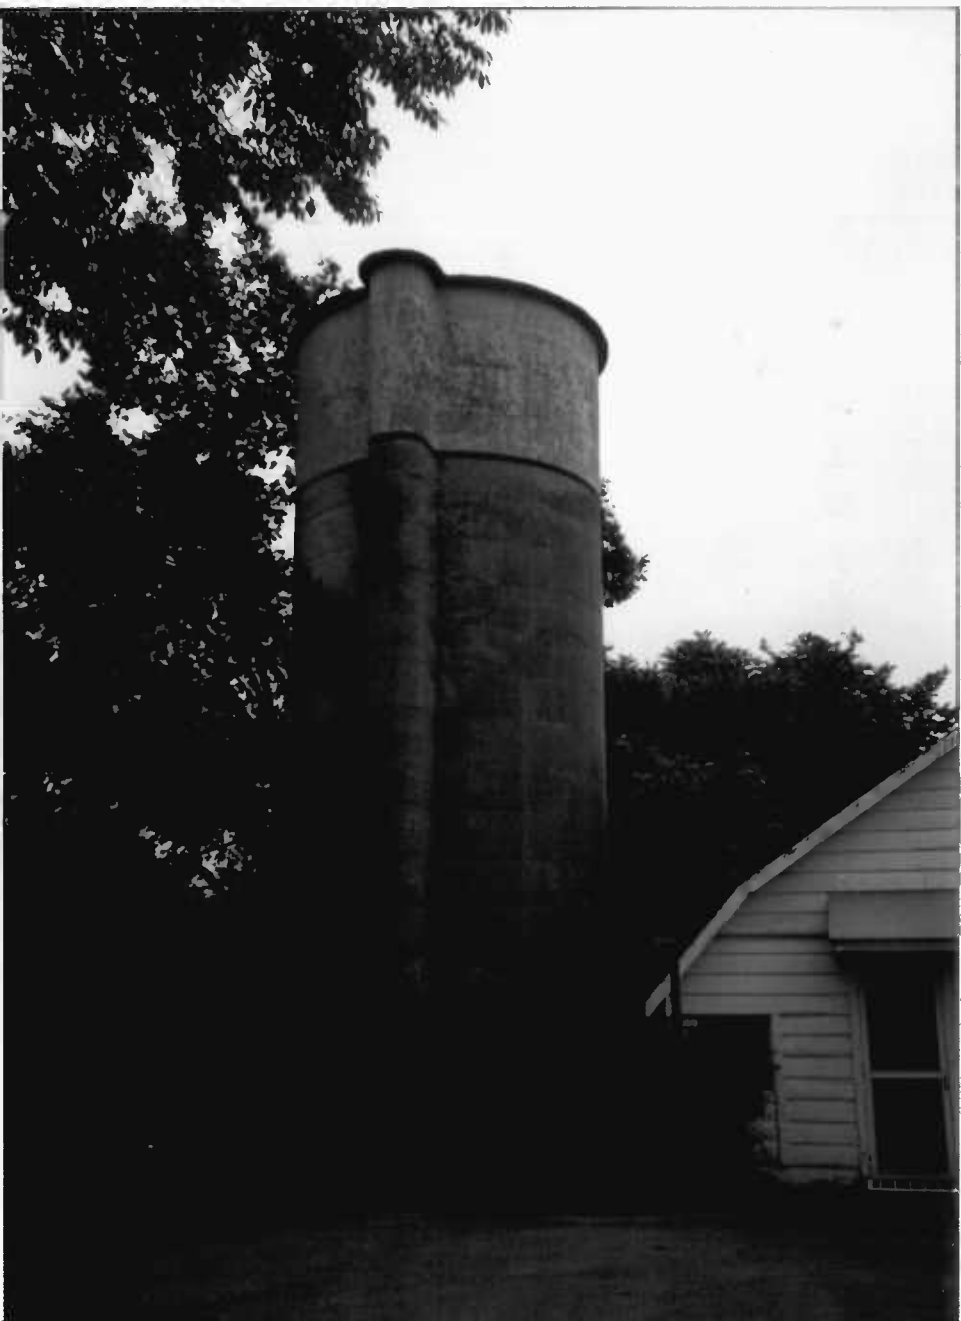
6 OF 13

Structure # 3 is located at the northeastern corner of Structure # 2 (dairy barn at 4296 Montgomery Road). It is a silo constructed of steel reinforced concrete with a concrete roof. The silo's diameter is 15 feet and its height is about 35 feet tall.

STRUCTURE #3, SILO, FRONT ELEVATION,
LOOKING SW.

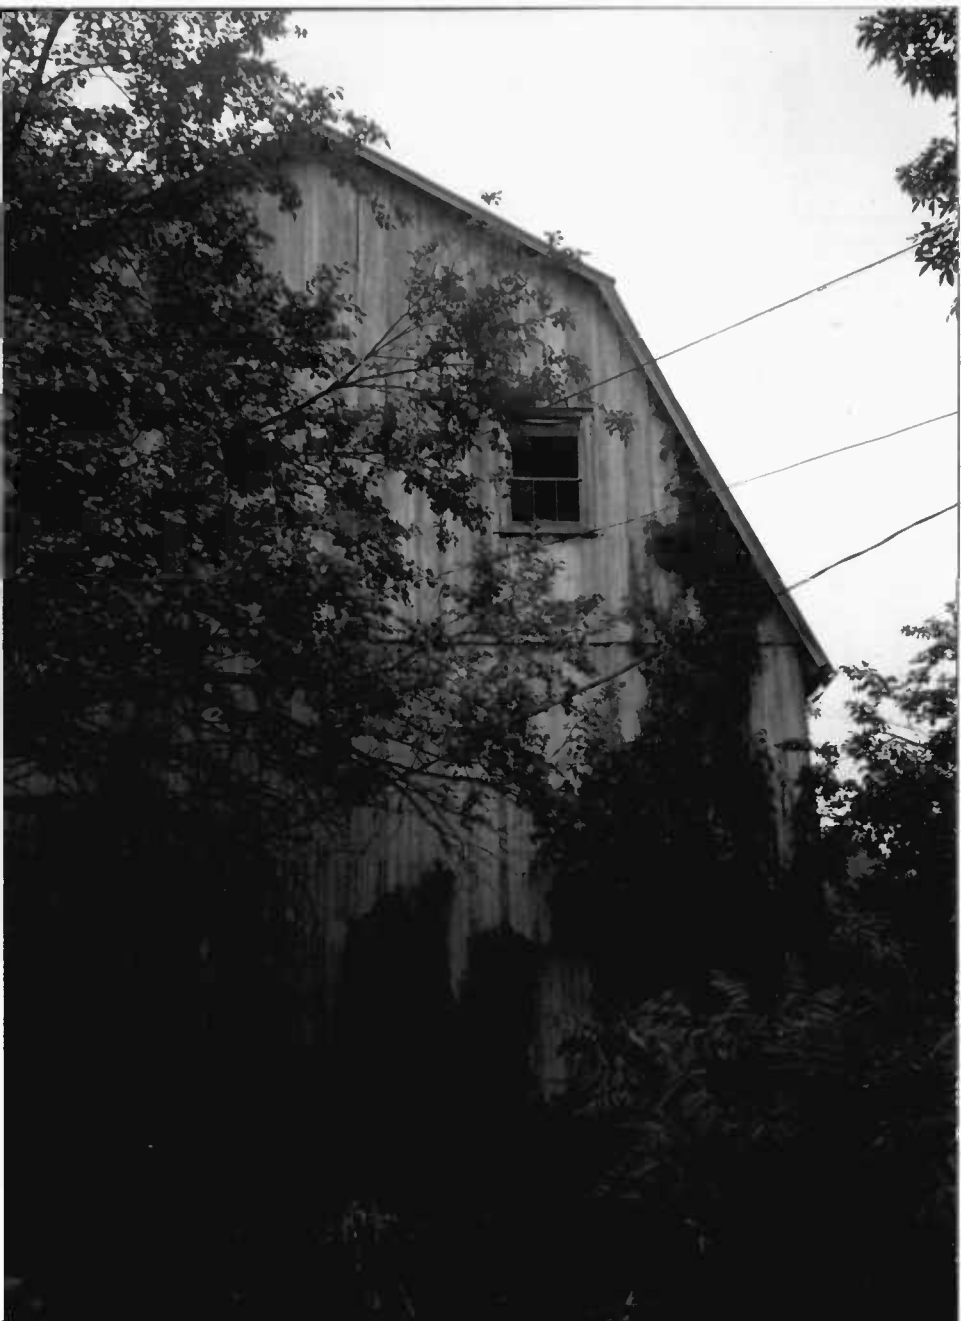
7 OF 13

STRUCTURE #4, BANK BARN, WESTERN END
ELEVATION, LOOKING EAST.

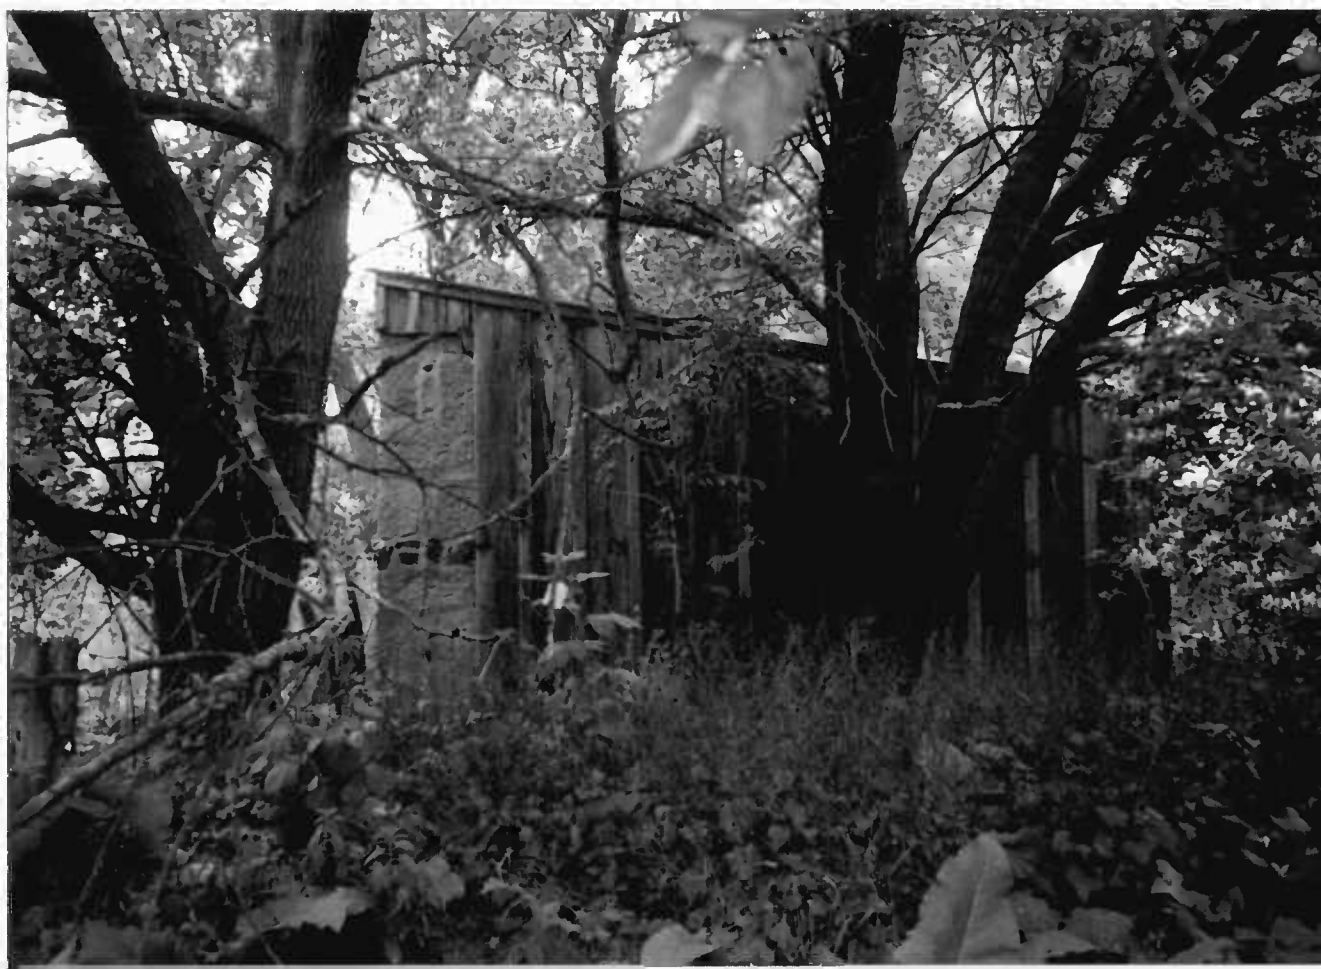
9 OF 13

STRUCTURE #5, FRAME SHED WITH STONE WALL,
SOUTHERN END, LOOKING NORTH.

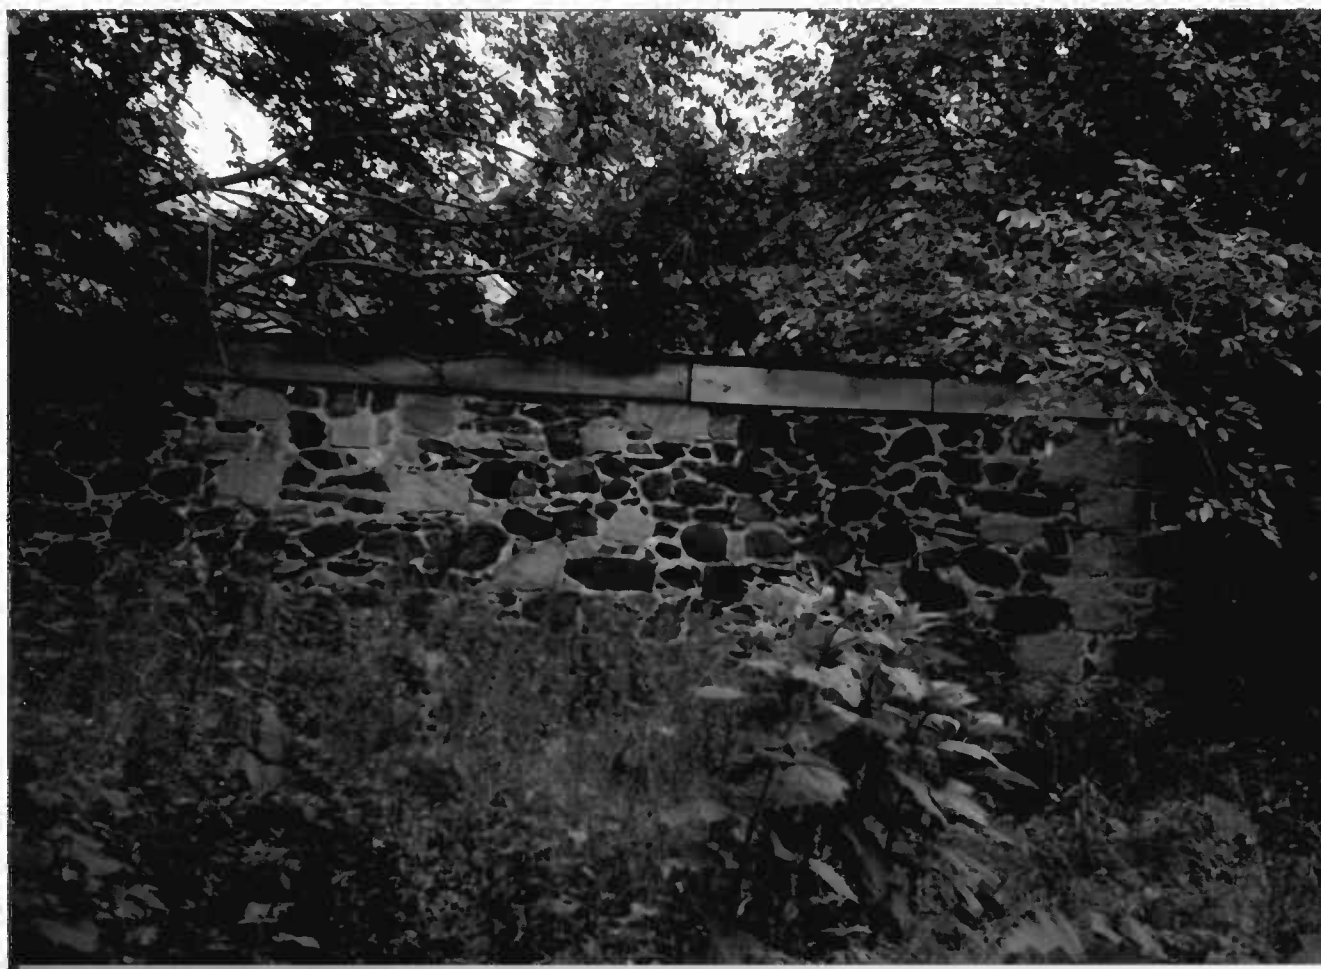
10 OF 13

STRUCTURE #5, FRAME SHED WITH STONE WALL
REAR OF WALL LOOKING EAST.

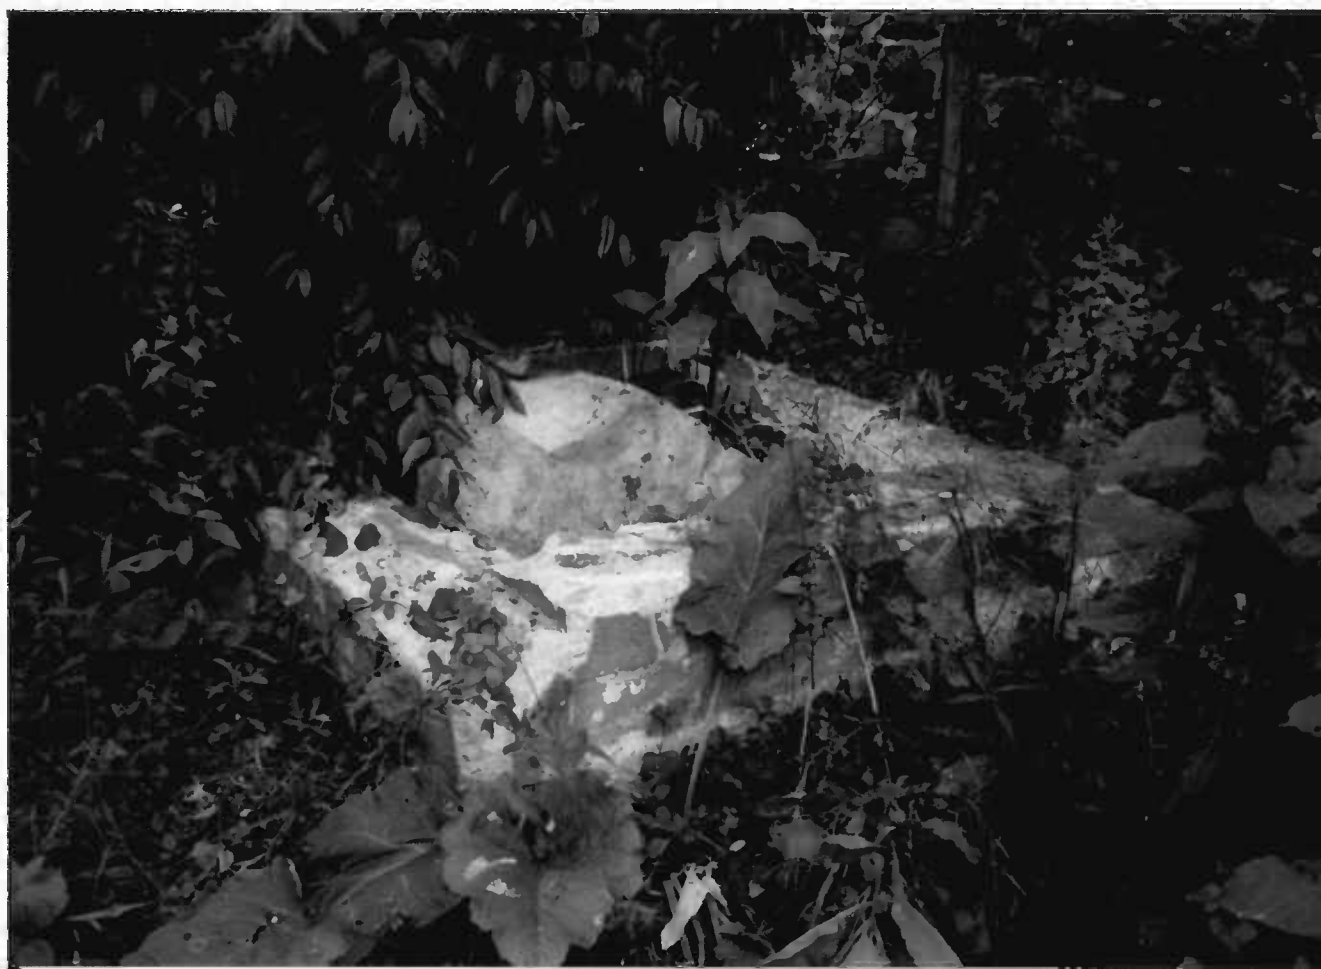
11 OF 13

To the rear of Structure # 5 there is a small rectangular concrete outbuilding foundation. It is designated Structure # 6. This feature measures 6 feet by 6 feet square. Its walls are 12 inches thick and rise to 18 inches above ground level. It has one bay.

STRUCTURE #6, OUTBUILDING FOUNDATION,
LOOKING NORTH.

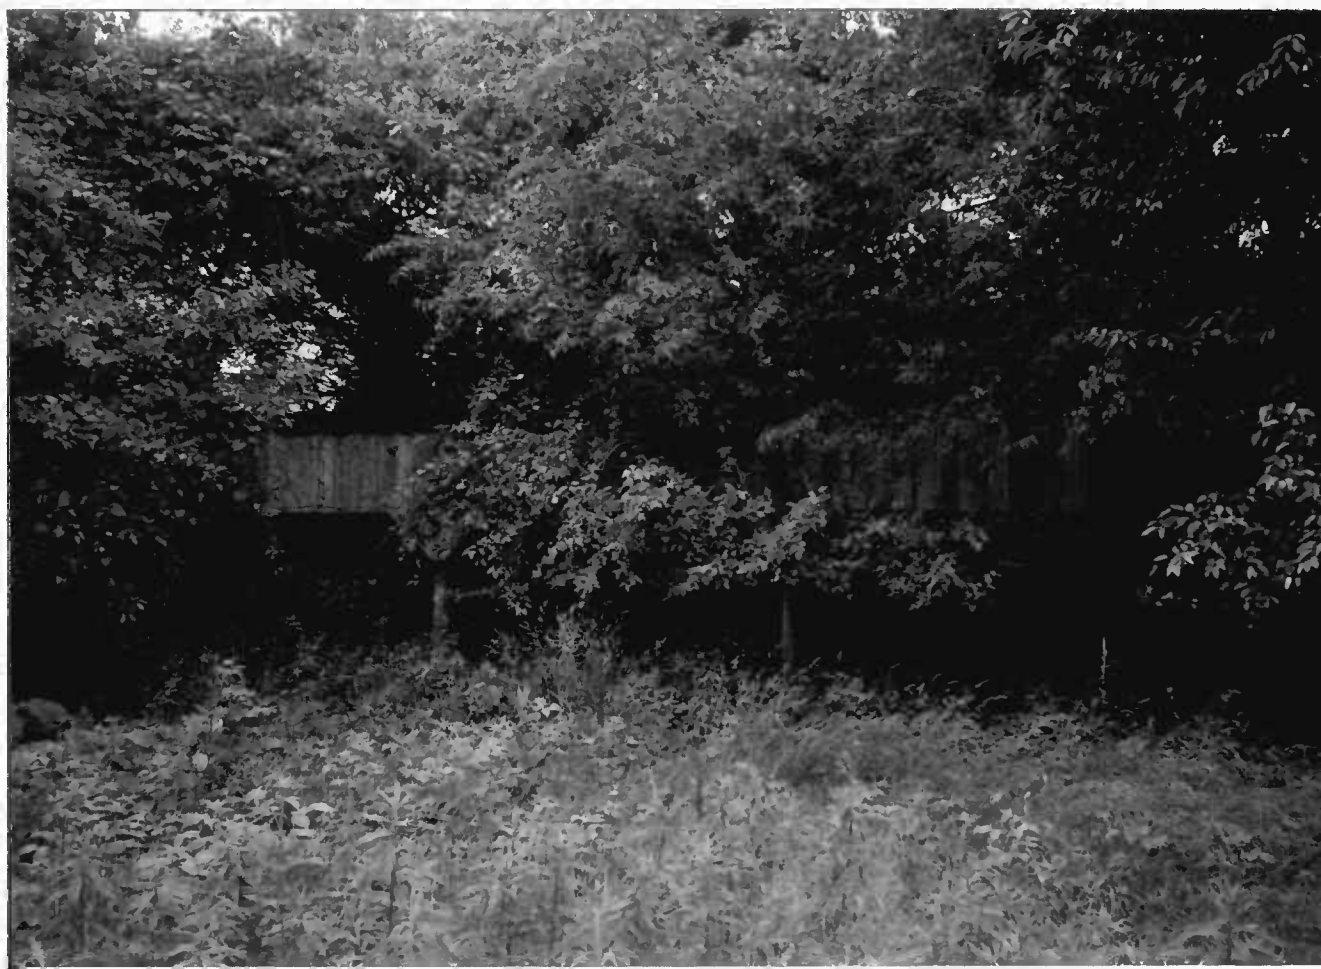
12 OF 13

Structure # 7 is a detached shed situated 84 feet south of Structure # 6. It appears to have served as a garage for farm equipment. A piece of abandoned farm machinery was observed adjacent to the structure.

STRUCTURE #7, GARAGE SHED, FRONT
ELEVATION, LOOKING NORTH.
